CWRP WEEKLY CONSTRUCTION PROGRESS REPORT

Week ending May 4, 2013

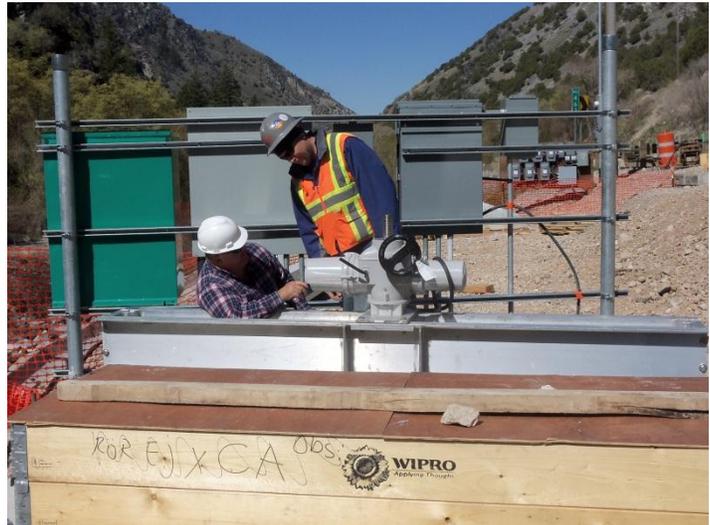
On May 2, 2013, the water master opened the river diversion head gate and water was officially diverted into the new system. Representatives from the Cache Highline Canal Company, Cache County, NRCS, MWH, J-U-B, and Whitaker Construction were on hand to witness the opening of the head gate. Once the gate was open, the group was able to see how the diversion structure operates.

Opening the head gate at the river diversion

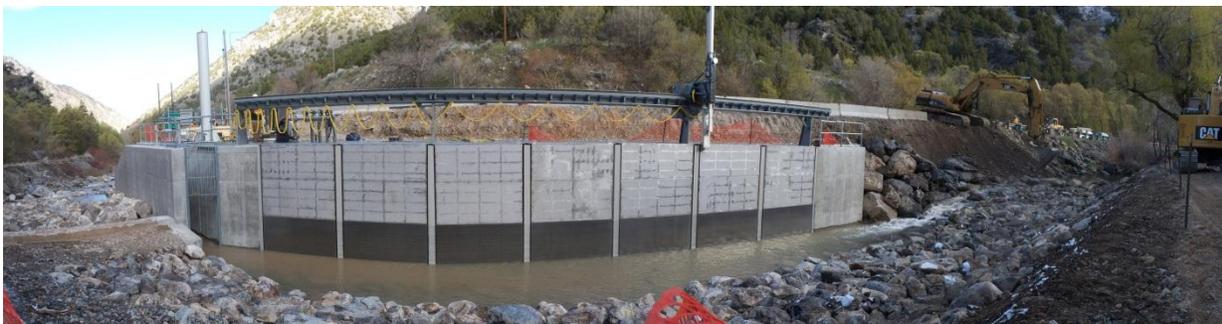
This week on the River Diversion, the coffer dam was removed and water was allowed to pass through the diversion structure. Most of the week was spent in preparation for the opening of the head gate which included electrical work and placing of rip-rap up stream of the structure. Willows and trees were also planted this week on the south river bank to restore natural vegetation to the river bank.

Operating river diversion structure

Next week, Whitaker will continue to work on other miscellaneous items on the diversion structure including installation of the jib crane, placement of the fish bi-pass, and installation of the rock retaining walls. Freedom Electric will also be on site to continue the rest of the electrical installation. Representatives from The United States Geological Survey (USGS) will also be on site next week to calibrate their flow measurement device just down stream of the river diversion.

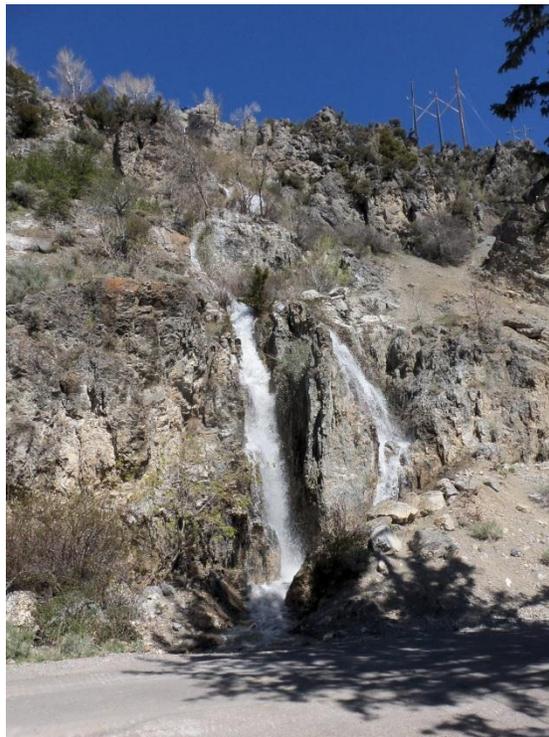
Spindler Construction had a crew inside and outside of box grouting tie holes and addressing some final punch list items. Toward the end of the week, a pre-water inspection of the box was conducted to verify that all of the punch list items had been addressed. The inspection yielded no other punch list items and the inside of culvert was approved for water transmission. On May 2 an initial flush at the bypass structure occurred after which the bypass was shut and the water was allowed to run to the transition structure.

Water spilling from the bypass structure at the mouth of Logan Canyon

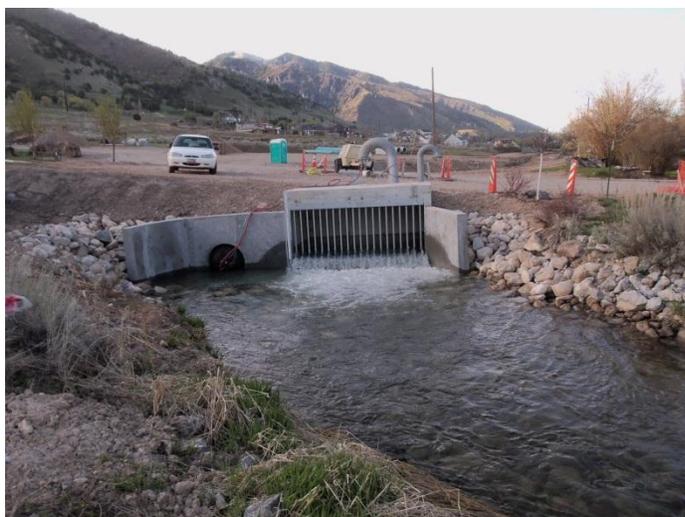
Water Flowing out of the bubble up structure into the LHPS open canal

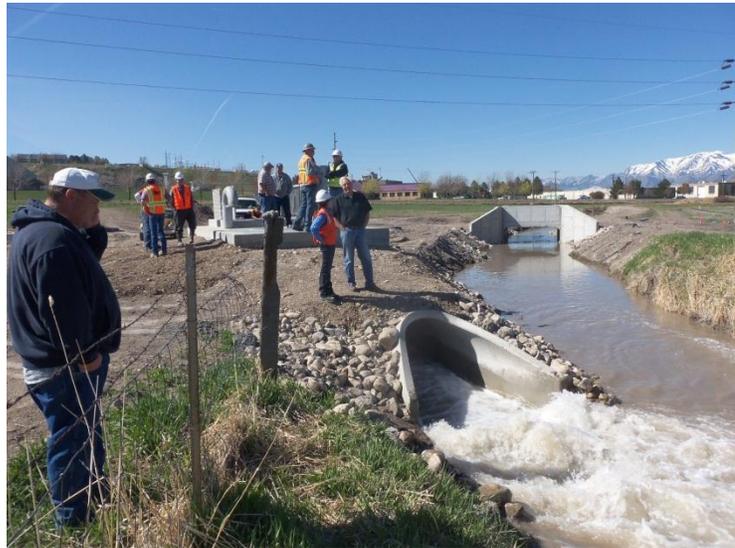
Water running into the Logan and Northern Canal via the 1500 N pressure reducing structure

Next week Whitaker will continue to do minor clean up items near the pressure reducing structure and prepare for the access road installation. Work will also continue near the diversion structure, on the east end of the segment, to prepare the area for pavement and finish work.

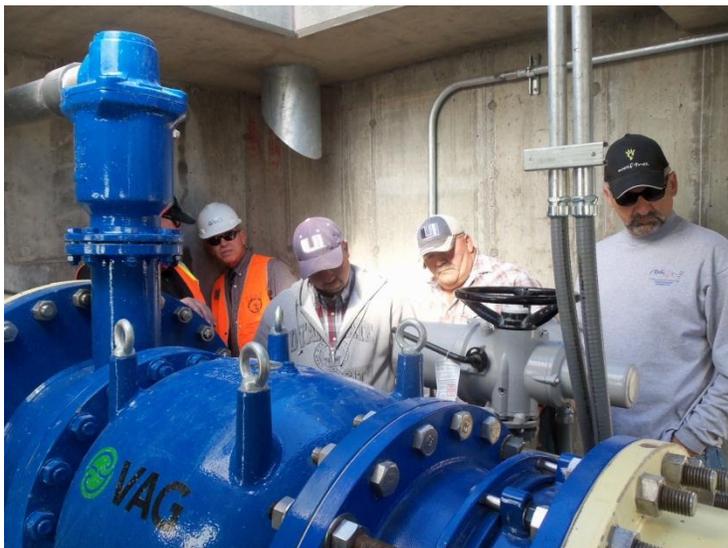
On May 3, 2013 an official training of the plunger valve occurred. Representatives from the Cache Highline Canal Company, Cache County, NRCS, MWH, J-U-B, and Whitaker Construction were on hand to listen to the training and watch the plunger valve operate. The valve was opened to various percentages as the project team observed operations. A formal training was given to the water master and he was able to familiarize himself with the system.

Plunger valve training

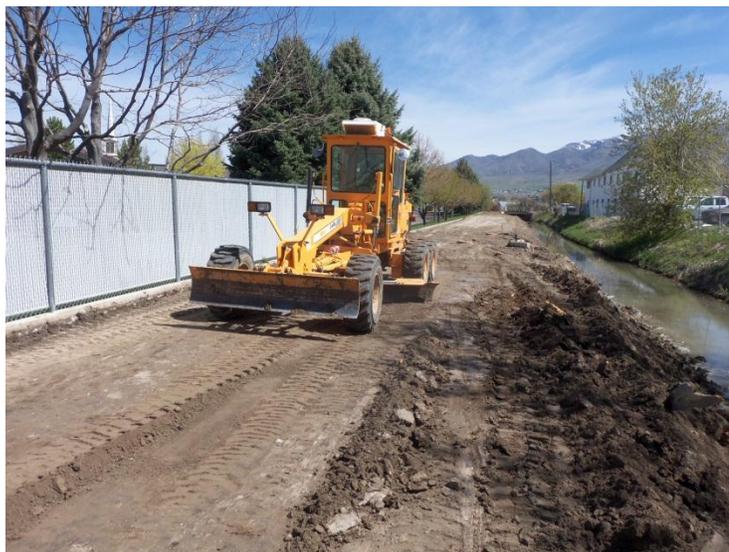
At the end of the week, crews began rough grading the old canal bank in preparation for the access road that will be installed in the coming weeks.

Grading the access road

Next week the water master and representatives from the project team will go through the segment and begin turning on the individual turnouts. Water users along the channel will again be restored to full water use. Whitaker will continue to rough grade the road and install the 24 inch RCP storm drain near the 400 N and 600 E intersection.

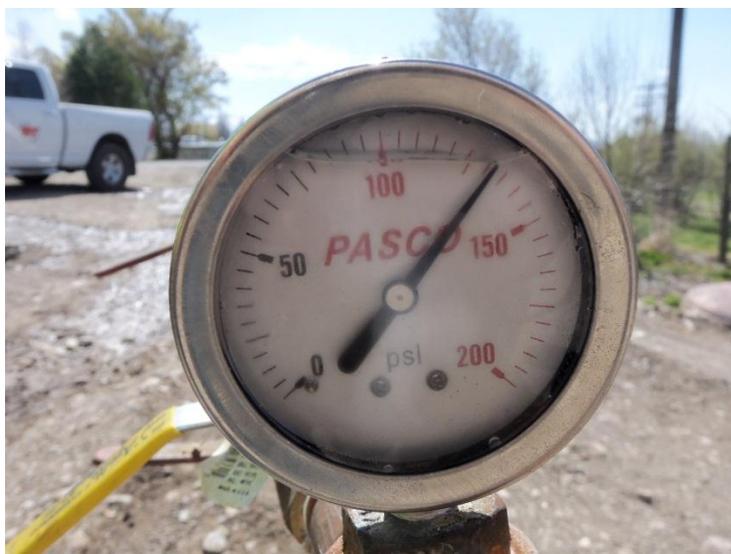
Crews this week finished the process of filling the main line and preparing it for a pressure test. In the middle of the week a pressure test was conducted on the main line pipe. To pass the pressure test the mainline is required to hold a pressure of 125 psi for two hours. The pressure test passed with no sign of defects or leaks.

In the middle of the week a pressure test was conducted on the main line pipe. To pass the pressure test the mainline is required to hold a pressure of 125 psi for two hours. The pressure test passed with no sign of defects.

Pressure gauge used during the pressure test on Logan and Northern and 1500 N main lines
