CWRP WEEKLY CONSTRUCTION PROGRESS REPORT

Week ending April 27, 2013

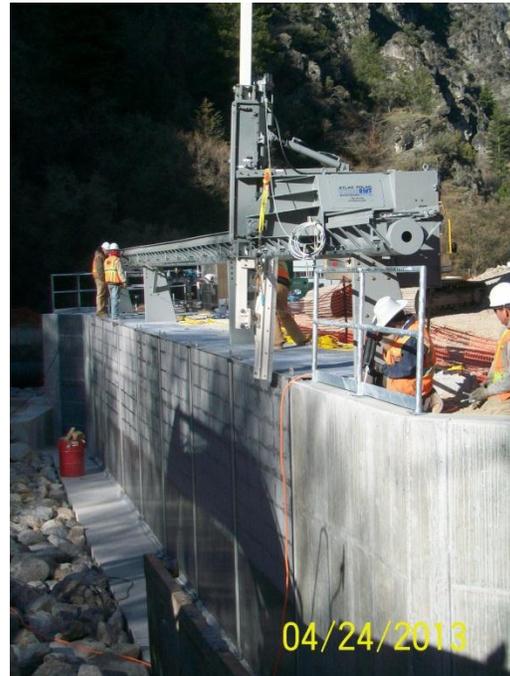
This week on the River Diversion, the screen cleaner arrived and was assembled above the intake screens. A representative from Atlas Polar, the manufacturer, was onsite to oversee and assist in the installation process. Installation went very smoothly and the cleaner was ready for operation a few days earlier than planned. Some fine tuning of the different functions began toward the end of the week and will continue through next week.

Installed Screen Cleaner

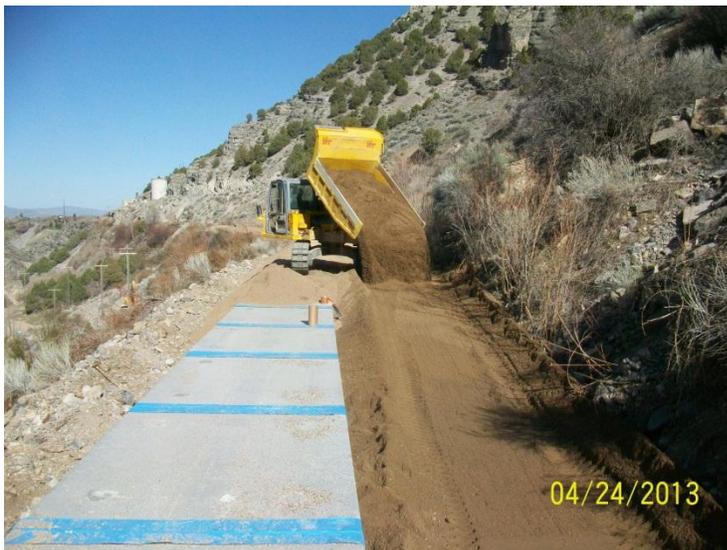
This week in the canyon, Whitaker continued backfilling the pre-cast culvert near the middle access road. Material from a Cache County gravel pit was used as fill material and placed with a small loader, small excavator, and track mounted rotating dump truck. Work was meticulous as the width of the channel doesn't allow larger machines to work.

Backfilling pre-cast box culvert

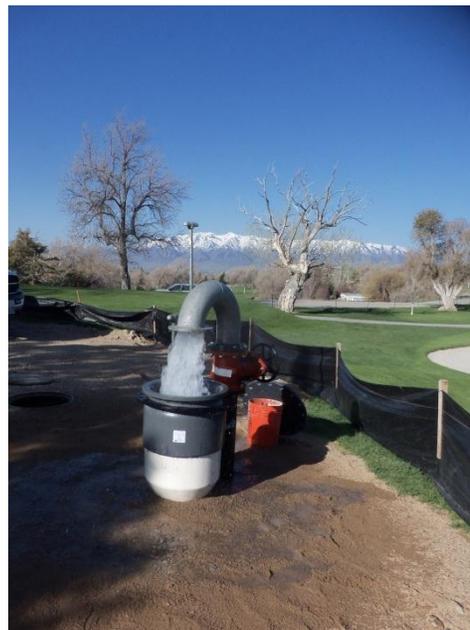
This week on the Valley Segment, Whitaker have been cleaning and preparing the pipeline for water. Water delivery was provided to the Logan Golf and Country Club through a culinary water connection with Logan City.

Delivering culinary water to Logan Golf and Country Club

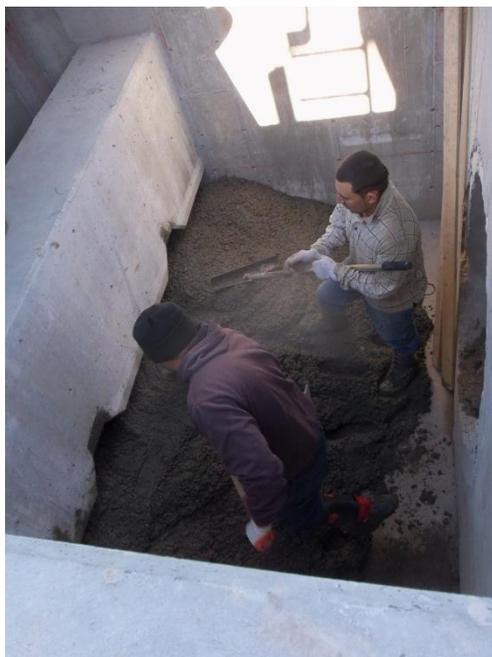
Pouring the sloped floor in the north bay of the pressure reducing structure

A few of the sub-contractors were also on site this week including Spindler Construction and Freedom Electric. Spindler was able to complete the installation of the sloped floor in the north bay of the pressure reducing structure along with the valve pedestal under the plunger valve. This completes Spindler’s work on this segment. Freedom Electric pulled electrical wires through the conduit and began preparing the plunger valve for operation.

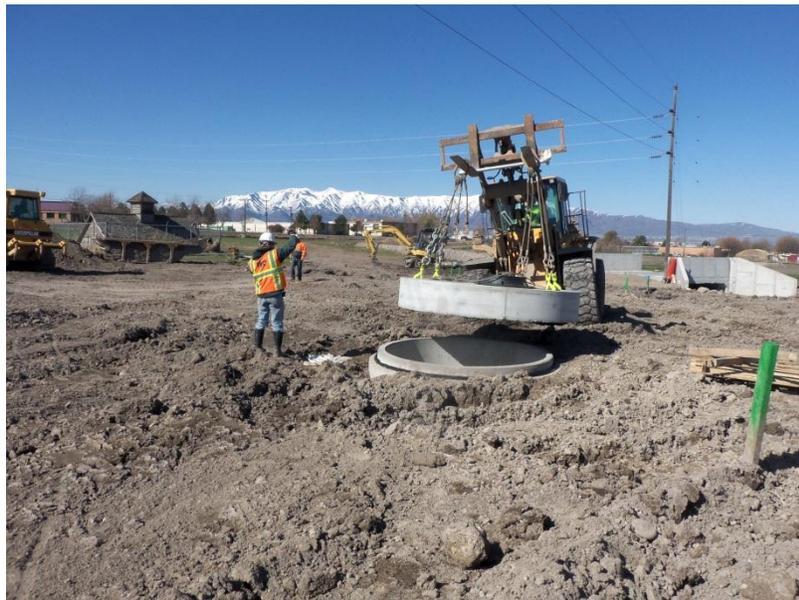
Placing a lid on the 96 inch man hole

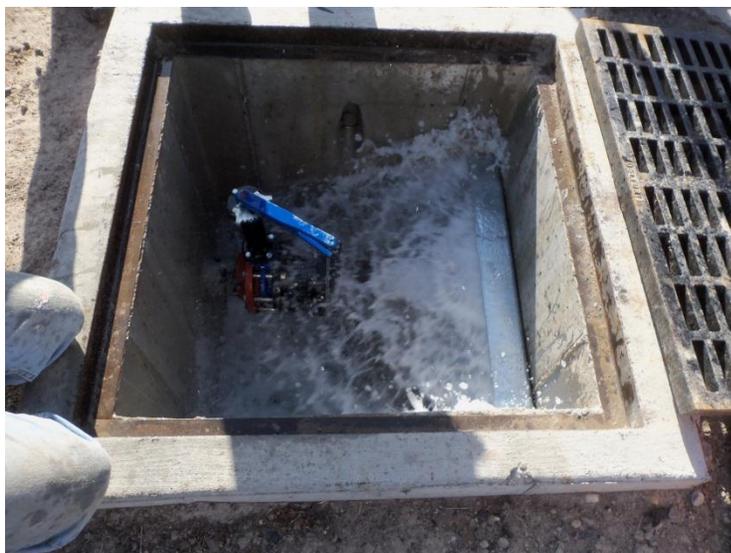
Gravity turnout energy dissipation box

A second crew went through the segment this week and installed all of the plumbing in the gravity turnout

boxes including butterfly valves and orifice plates. As there was water in the mainline for the pressure test, a few of these gravity turnouts were turned on to test them out and view how they will operate.

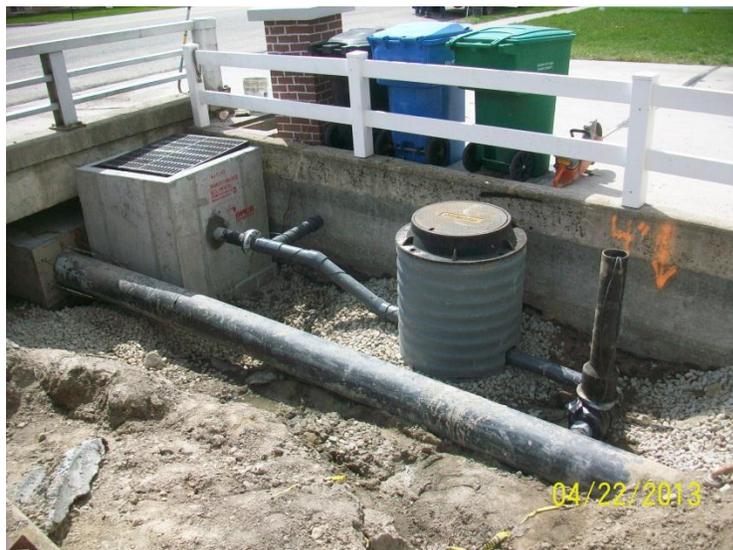
Turnout slightly north of the 400 N crossing
